## AtlasIED Application Note

# Updating Titan Frames to Use with GLOBALCOM

Ver 1.0 29 November 2018

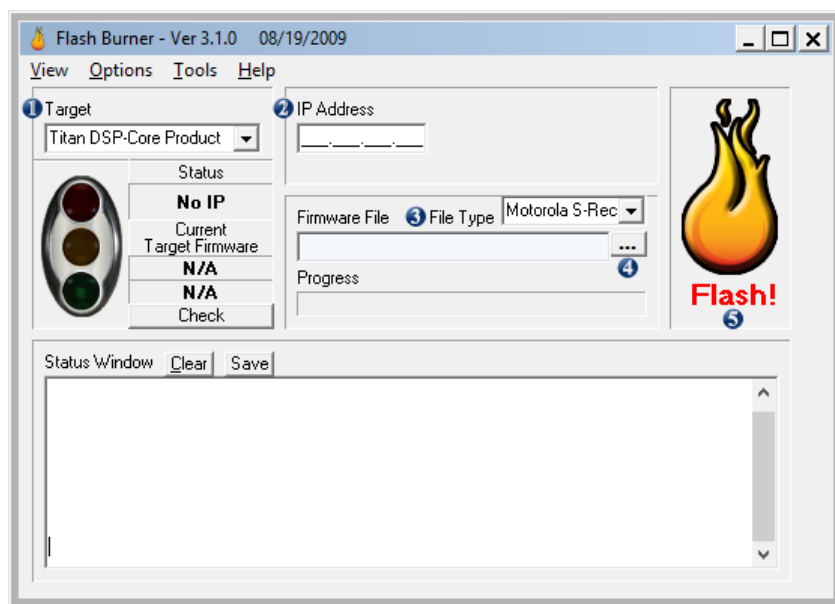
The main tool for updating the Titan firmware over the network is FBurner.exe. This tool is located on a GLOBALCOM system in the C:\IED\Tools\Titan folder. One should run the latest version found (usually 3.1.0). Simply double-click FBurner3\_1\_0.exe to launch the application. The window one should see is as shown below.

The little blue circled numbers that appear on the user interface indicate the steps to follow when using this tool. For this situation, it is useful to insert a step between ② and ③. This extra step insures that one is talking to the frame on the network and retrieves the current firmware version which is used to determine which version of the latest firmware to apply to this frame (as explained in Appendix A and listed in Appendix B).

① Select product family – *Leave at the default “Titan DSP-Core Product”*

② Fill in IP Address of the frame

<Insert Step> Check the current firmware version by clicking on the [Check] button. The bottom-most box shows the version, with the last digit split out. In the example shown at right, this would also be expressed as version 2.9.5.2 .

③ Select file type – *Leave at the default “Motorola S-Rec”*

④ Locate the correct version of the latest firmware file on your local system by clicking on the [...] button to bring up an open dialog box. Be sure to only select a file with extension .A79 (Motorola S-Rec format) and appropriate to the frame’s hardware.

- 5 Click on the big flame icon to start the firmware update process.

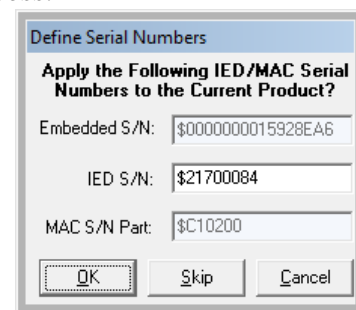
Soon after this process starts, it will read in the frame's current serial number and present the prompt shown at right. For frames being updated, you should just click on the [OK] button (or hit the [Space] bar or [Enter] key on the keyboard) to allow the update to continue with the existing serial number.

The dialog box is titled "Define Serial Numbers" and contains the text "Apply the Following IED/MAC Serial Numbers to the Current Product?". It has three input fields: "Embedded S/N:" with the value "\$0000000015928EA6", "IED S/N:" with the value "\$21700084", and "MAC S/N Part:" with the value "\$C10200". At the bottom are three buttons: "OK", "Skip", and "Cancel".

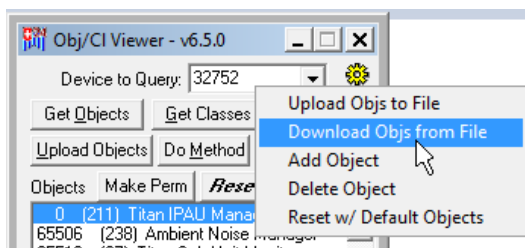
The ViewProp.exe tool should also be in C:\IED\Tools\Titan. Double-click it to run and following the steps shown in the graphic below. (Note, the circled numbers do not appear on the ViewProp program window like on FBurner, but are only shown in this document for instructional purposes.)

- ❶ Enter 32752 into the Device to Query edit box.
- ❷ Click on the IP address box to bring up the pop-up box.
- ❸ Enter the frame’s IP Address and click on the [OK] button in the pop-up.
- ❹ Click on the [Get Objects] button to verify communications with the frame
- ❺ Bring up the special operations menu button by clicking on the [▼] button. This should bring up the menu shown below.

Select “Download Objs from File” menu option. This should bring up an Open dialog box where one locates the local copy of the T9116ZOP.iob file and clicks on the [OK] button.
